# The Nautical Institute Marine Accident Reporting Scheme

MARS Report No 184 February 2008

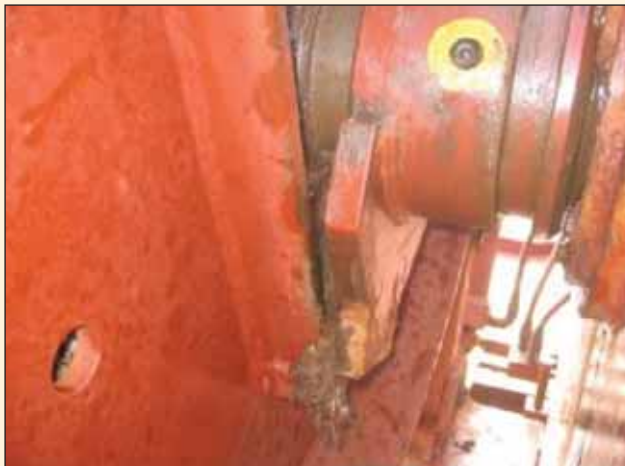
The bosun and a seaman were carrying out routine greasing of a mooring winch. In order to remove the dried old grease around the dog clutch and shaft, it was necessary for the seaman to extend his arm between the drum and the winch drive gear and clear it manually. With the bosun following the instructions from the seaman, the winch was being rotated intermittently, while the seaman proceeded with the task when the winch was immobile.

During one such pause, the shaft suddenly began to rotate unexpectedly, and the sleeve of the seaman's parka got caught in the clutch assembly, quickly drawing his hand into the rotating part.

1. The winch power supply had not been isolated before commencement of work;
2. Loose fitting parka and inadequately fastened sleeve cuff.

▲ View of dog clutch into which the parka sleeve and hand were drawn

1. Machinery or moving gear should be de-activated before any maintenance is carried out on or near them.

2. If work on a moving system cannot be avoided, the job must be carried out by two persons at least, one of them being in position to activate the emergency stop at any moment.
3. Clothing and personal protective equipment (PPE) must not be loose when working on or near moving systems.
4. Risk assessment should take into account every realistic hazard. Past risk assessments should be reviewed during onboard daily meetings so that previously identified hazards are not missed.

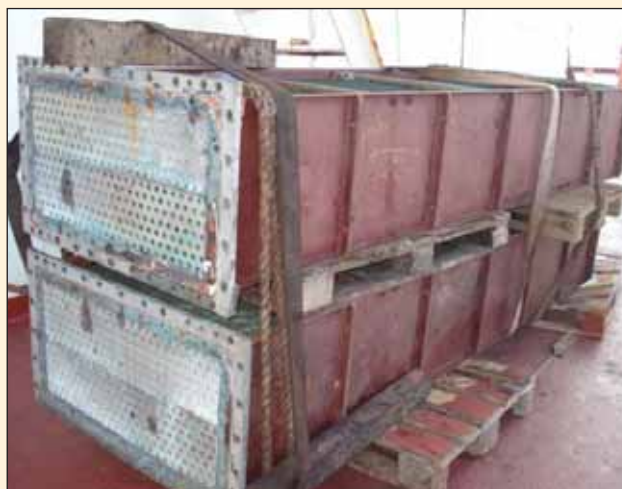
A cargo ship had recently renewed some heavy heat exchangers in the machinery spaces and the discarded units were retained for dumping in deep and open waters. They were temporarily stowed on the poop deck. During passage on

the high seas, without the knowledge of the bridge watch and with the ship steaming ahead at full sea speed, the units were transferred on to an improvised 'skid' placed on top of pipe lengths laid on deck and were 'rolled' overboard. This involved temporary removal (gas cutting and re-welding) of sections of poop deck railing. The point of jettison was only about 20 metres ahead of the propeller. At the next port, the vessel underwent a routine underwater hull coating inspection and the divers reported damage to the propeller blades.

As well as floating debris, the indiscriminate dumping of large and heavy objects from near the stern can easily damage the propeller and rudder, as the trajectory under the water may be affected by the suction effect of the propeller. If the damage is serious, the vessel may be disabled far from SAR (search and rescue) services, with serious consequences for life, property and the environment.

▲ Heat exchangers on poop deck before unauthorized dumping.
